Computer vision and machine learning for the detection and classification of pavement cracks

Lizette Tello-Cifuentes¹

Cómo citar: Tello-Cifuentes, L., Marulanda, J., Thomson, P. Computer vision and machine learning for the detection and classification of pavement cracks. *Ingeniería y Competitividad*. 2023, 25(2); e-20512143. doi: <https://doi.org/10.25100/iyc.v25i2.12143>

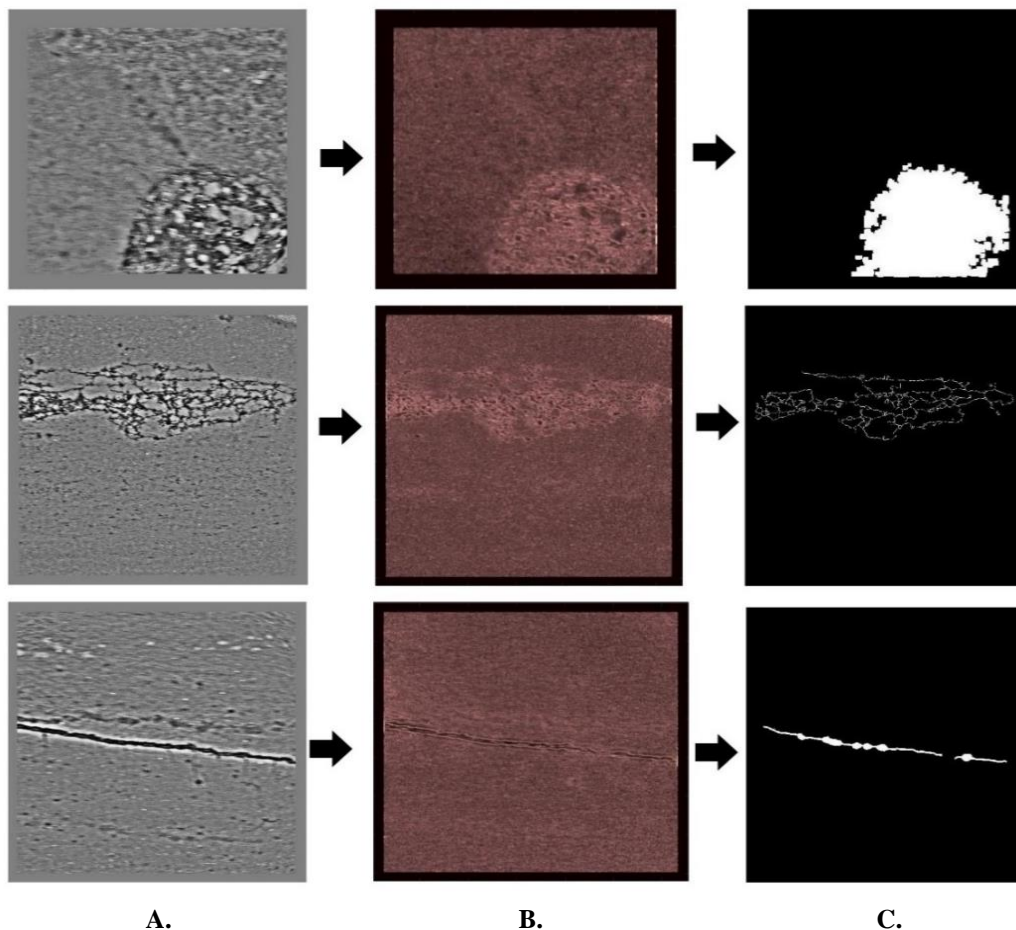
Figure 1. Images were obtained in the processing stage, for each of the deterioration pothole, alligator crack, and longitudinal crack. A. Images with contrast enhancement, B. Images obtained from the Scattering transform, and C. Images obtained after noise removal.

A single method cannot be used for edge detection of different distress types. Potholes and alligator cracks are most effectively detected using the Prewitt method, whereas Canny is most effective for detecting longitudinal cracks. All images are preprocessed with both edge detection methods.

The edge-detected images are subjected to gap filling and denoising at different thresholds to identify the optimal threshold for noise removal. A single threshold value cannot be used for all three types of deterioration. Thus, different thresholds are applied according to the type of deterioration, as shown in Table 2.

As the considered images had different sizes, the processing time varied with the image dimensions. The maximum processing time of 3 minutes and 10 seconds was determined by the wavelet scattering transform, the most time-consuming process. This transform highlighted the deteriorations by producing data representations that minimize differences within a texture type and discriminate textures, thereby improving edge detection. Figure 1 shows the images obtained at different processing stages for each type of deterioration.

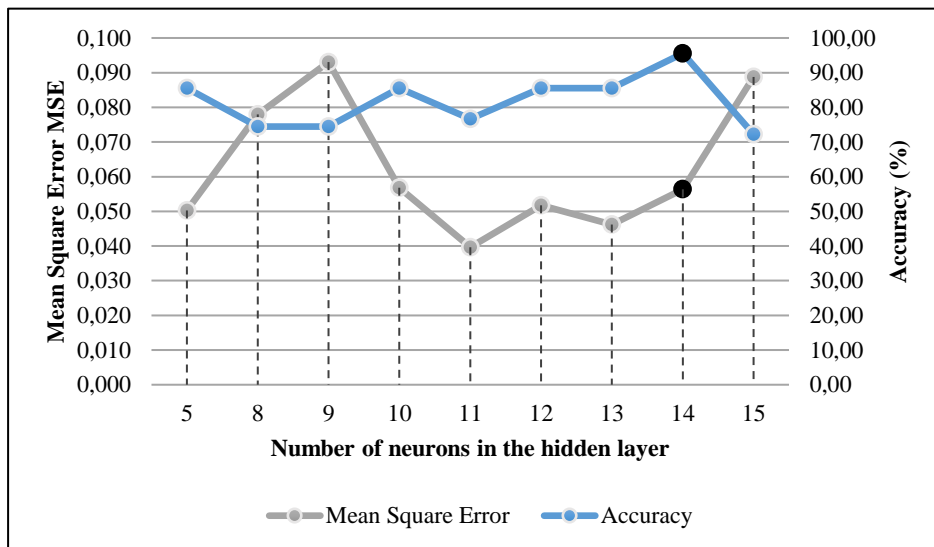
Figure 2. MSE and accuracy obtained for the selected neural networks.

network architecture that would yield the highest classification performance. This approach allowed for a comprehensive evaluation of the neural networks and their ability to accurately classify pavement deterioration. This provided valuable insights into the impact of the hidden layer configuration on the performance of the classifiers. By comparing the accuracy and precision metrics of each network, it was possible to identify the neural network with the highest overall performance. The input layer was composed of a 12-dimensional feature vector based on the Hu moment invariants for three images obtained in the processing stage. The output layer was composed of three neurons coded according to deterioration type. The 10 neural networks with the lowest mean square error was used for validation. Figure 2 shows the classifier results.

The selected neural network had 12 neurons in the input layer, 14 neurons in the hidden layer and 3 neurons in the output layer. This network had a mean square error of 0.056, which was not the lowest value among the 20 networks, but it had the highest overall accuracy of 95.56% and a precision of 94.44%. Sensitivity and specificity performance metrics were also calculated for each type of deterioration. The sensitivities were 100% for both alligator and
