Assessment of rainwater quality in the biogeographical pacific. Preliminary study Quibdó, Chocó, Colombia

Yarly E. Mosquera-Torres¹

¹Grupo de Investigación Ingeniería Civil – IC, Universidad Tecnológica del Chocó, Quibdó, Colombia.

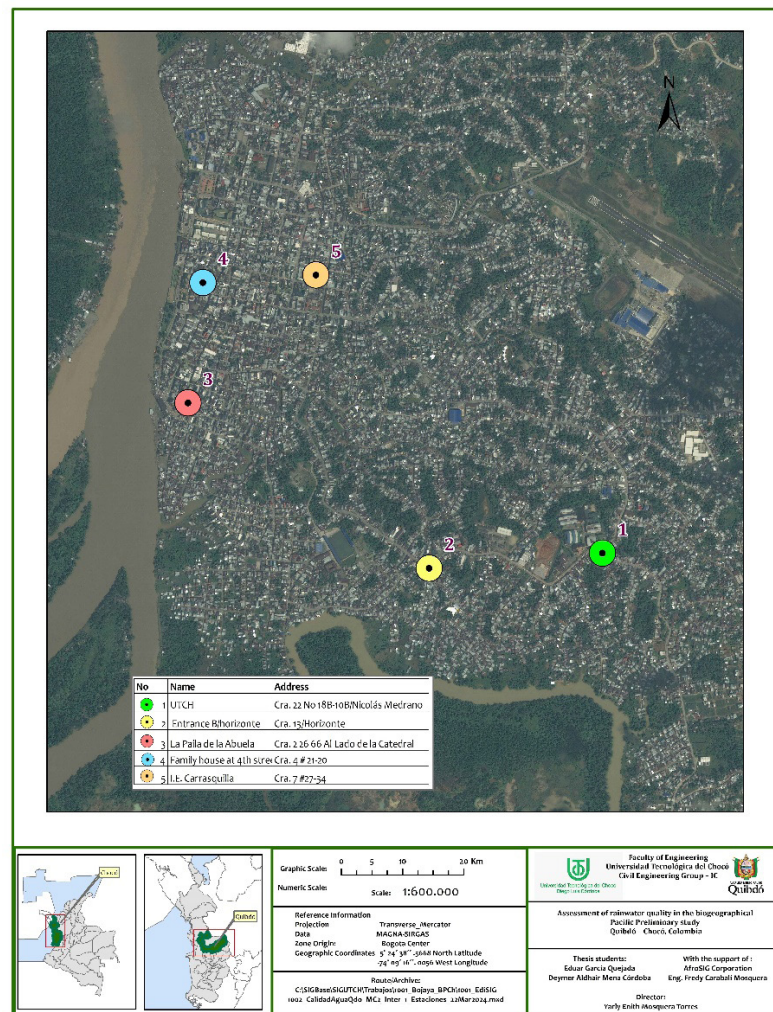
Figure 2. Sampling Points

20 fixed sampling points were established (see Figure 2), using homes that had roofs built of zinc, mantle and asbestos cement, because this type of material is used in the municipality of Quibdó. Additionally, a high vehicular and pedestrian flow was taken into account.

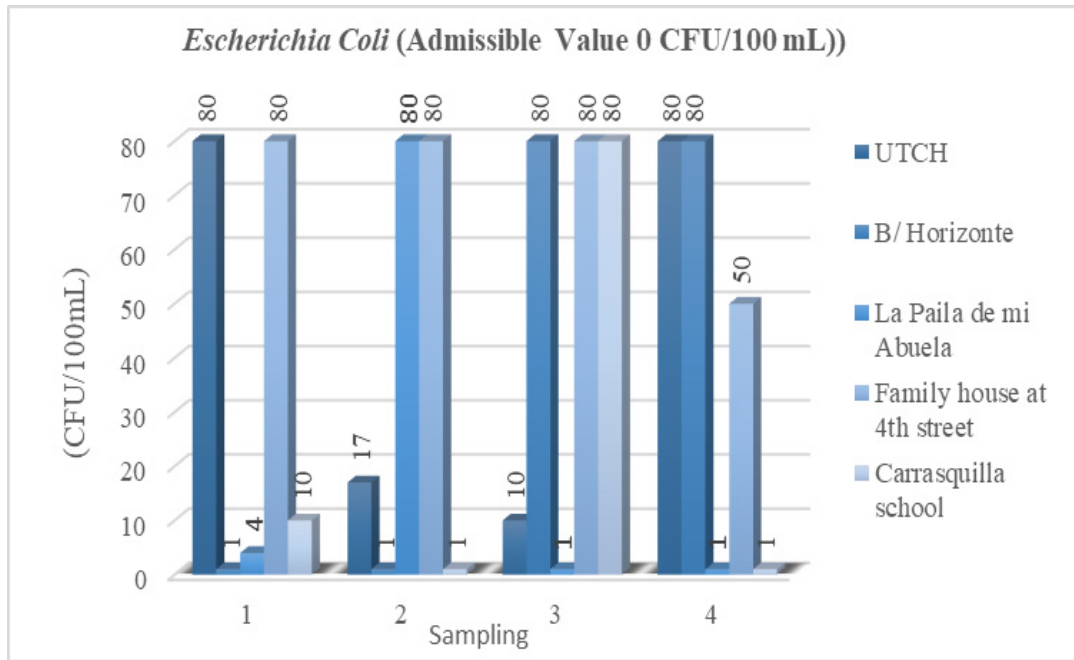
In the microbiological analysis, the presence of colony-forming units of Escherichia Coli and total coliforms was found in 100% of the representative samples, which indicates based on the current standards, that the water is not suitable for human consumption because Resolution 2115 of 2007 establishes that the acceptable admissible value is 0 CFU/100 mL, meaning that no water used for human consumption should contain E. Coli or total Coliforms (22). See Figures 3 and 4.

Figure 3. Results of Escherichia Coli

In addition, Figure 15 (map with a microbiological spectrum) shows the sampling results of the Escherichia Coli (EC) parameter. According to Figures 3 and 4, none of the points meet the values established for this parameter, which must be 0 CFU/100 mL. Points 1 and 4 have a higher intensity, meaning they have higher levels of Escherichia Coli compared to points 2, 3 and 5. This suggests that points 1 and 4 present a greater health risk and require immediate intervention.

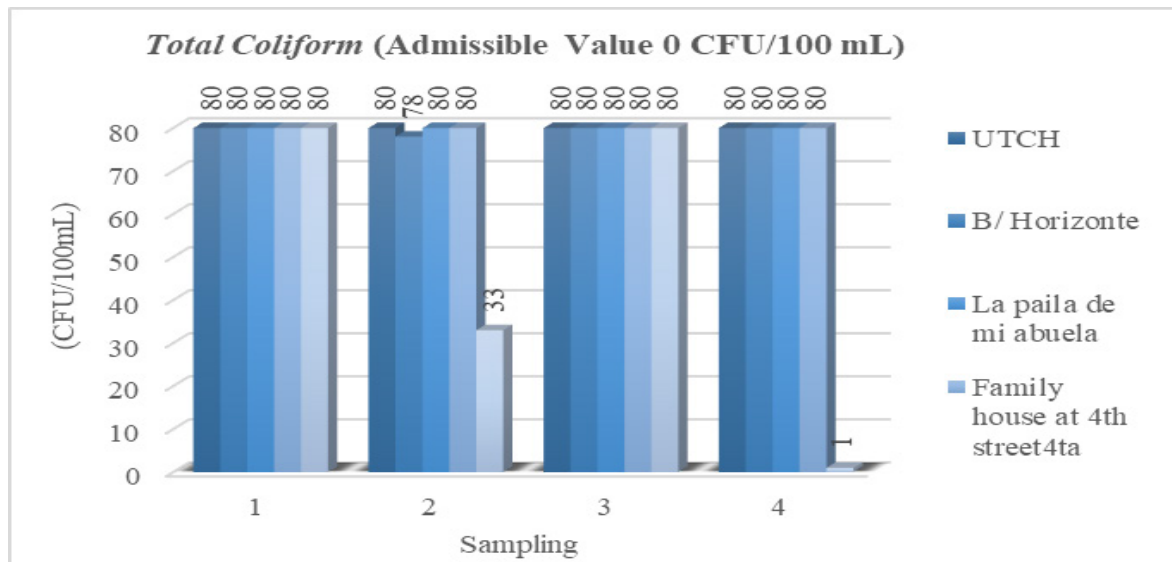
Figure 4. Results of Total Coliform

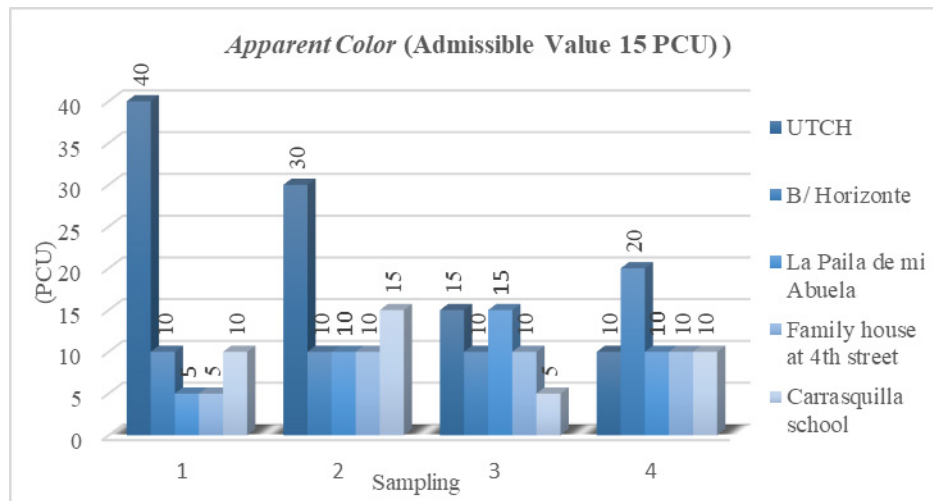
In the physical analysis, 15% of the samples regarding the apparent color parameter do not meet the admissible value (15 PCU), this could have been caused by slight droughts between the sampling periods. See Figures 5, 6, 7 and 8.

Figure 5. Results of Apparent Color

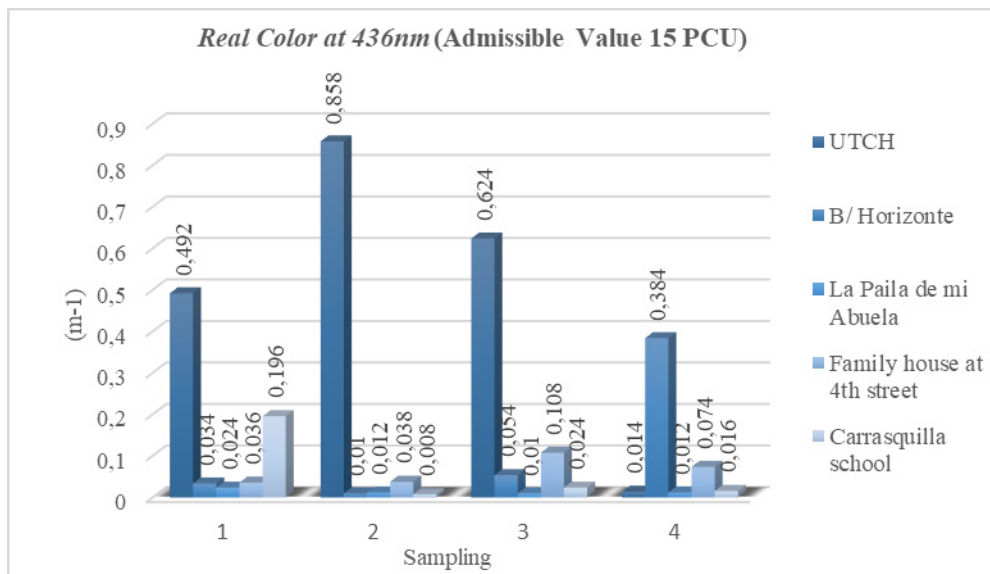
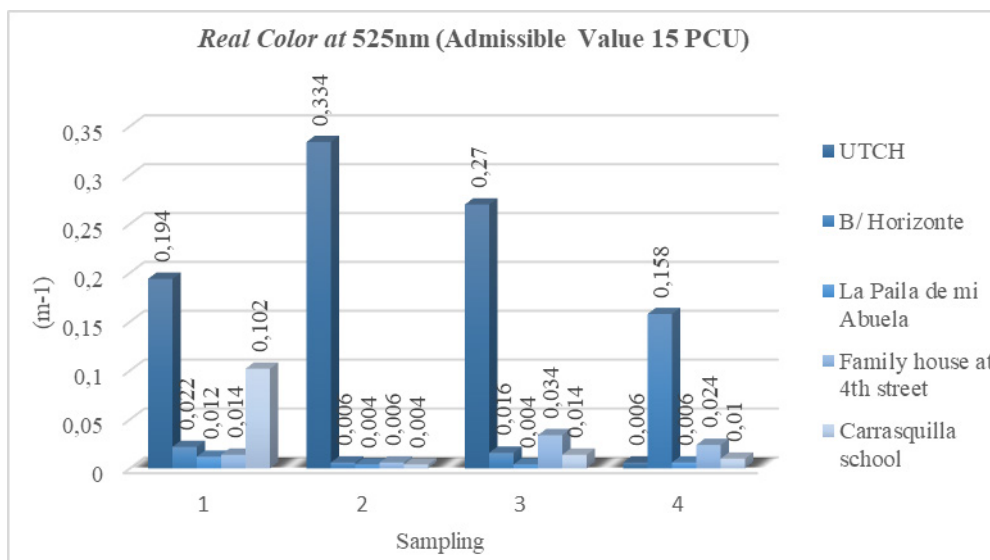
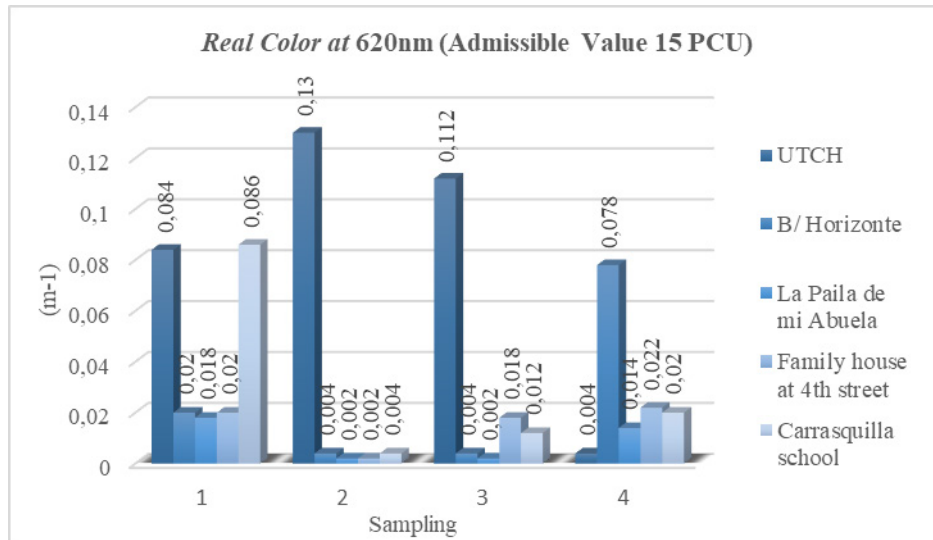
Figure 6. Results of Real Color at 436nm (m-1)

Figure 7. Results of Real Color at 525nm (m-1)

Figure 8. Results of Real Color at 620nm (m-1)

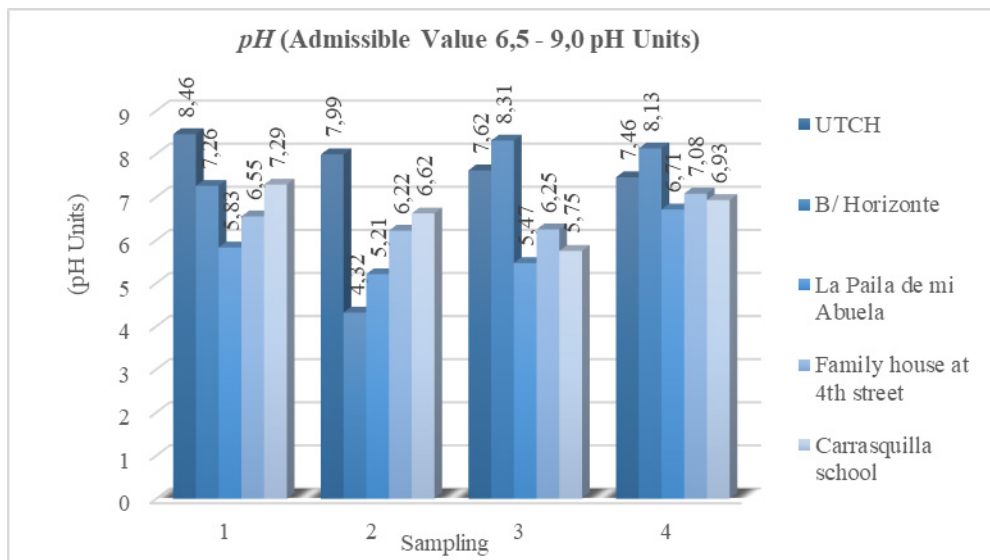
When performing the chemical analysis, 34% of the samples do not comply with the pH parameter since it is below the minimum admissible value, which ranges between 6.5 and 9.0 pH units. The results obtained in the analyzes indicate that the water is acidic, see Figure 9.

Figure 9. Results of pH

The results show that the pH of samples 1683WEO2, 1647WEO3, 1683WEO3, 1749WEO3, 1683WEO4, 1749WEO4 and 1749WEO5 is below the acceptable limit, indicating that the water is acidic. This may have been caused by the weather and atmospheric conditions at the time it was collected. It is observed that the apparent color does not comply with the allowed limits at points 1647WEO1, 1683WEO1 and 1814WEO2, which could be caused by slight droughts during the time of collecting the samples, the time and place in which the collection was carried out. In a study carried out in Guangzhou, South China, the research results showed pH values below the permissible range (29).

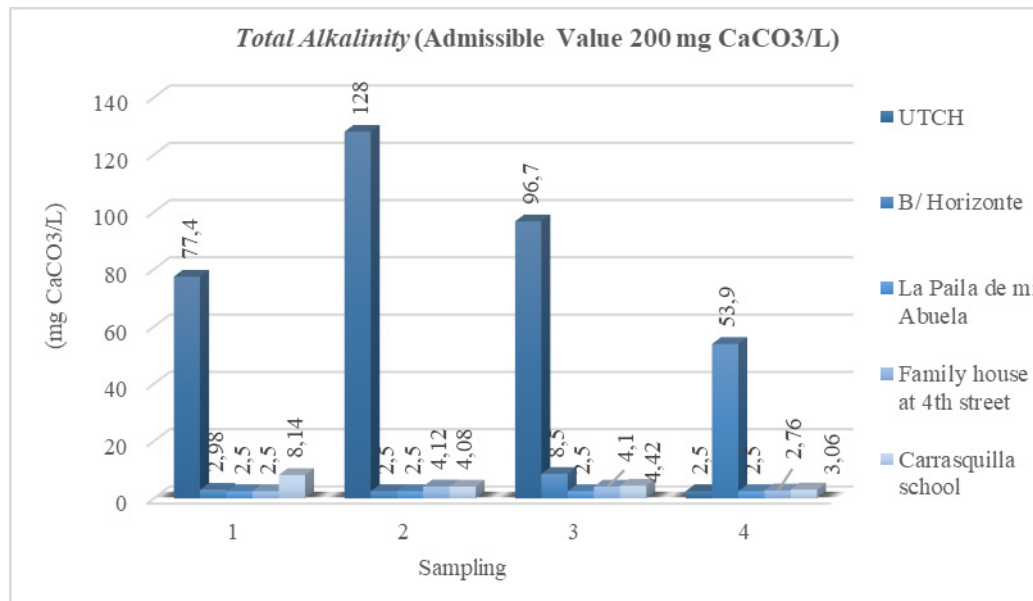
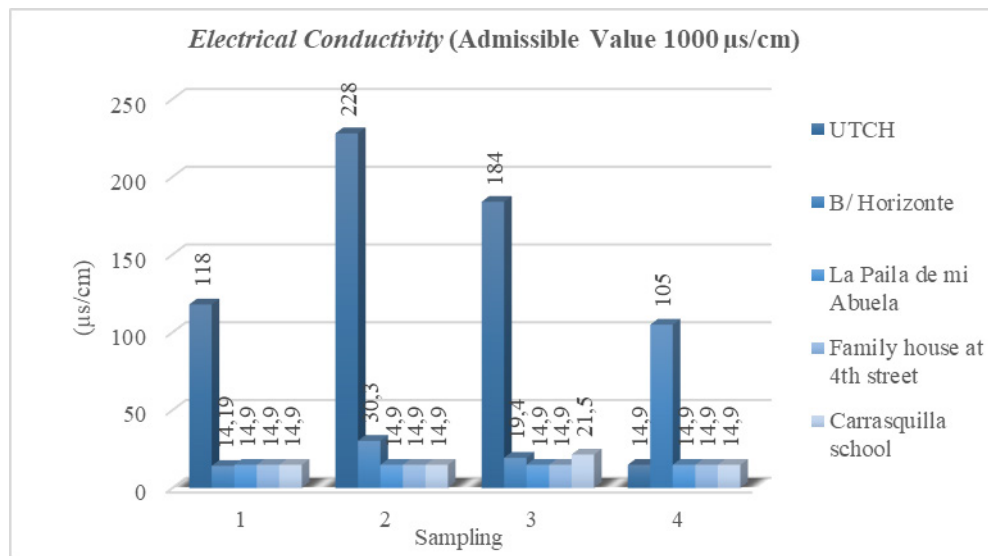
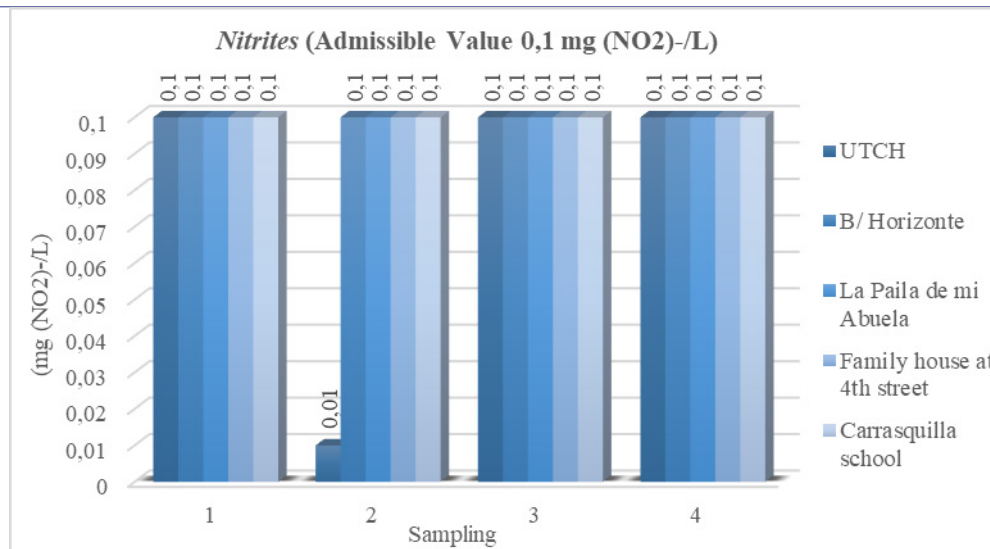
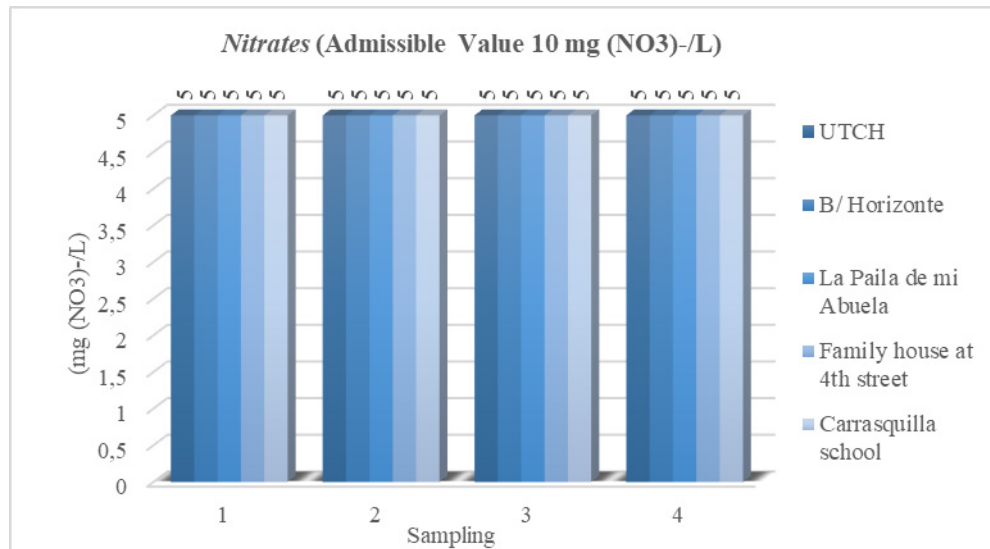
In relation to the parameters of alkalinity (200 mg CaCO₃/L), electrical conductivity (1000 µs/cm), nitrites (0.1 mg (NO₂)-/L) and nitrates (10 mg (NO₃)-/L) it is observed that they are within the admissible values, according to Resolution 2115 of 2007. See Figures 10, 11, 12 y 13.

Figure 10. Results of Alkalinity

Figure 11. Results of Electrical Conductivity

Figure 12. Results of Nitrites

Figure 13. Results of Nitrates

According to the parameters evaluated, it is observed that the color, electrical conductivity, nitrites and nitrates are within the limits allowed by Resolution 2115 of June 2007. The results for nitrites did not exceed the value of 0.1 (mg (NO₂)-/L), nitrates did not exceed the value of 10 (mg (NO₃)-/L) and electrical conductivity did not exceed 1000 (µs/cm). The University of Toulouse in France conducted a study called "Roof Runoff Water Quality Monitoring: Interpretation by Multivariate Analysis," which revealed the simultaneous presence of Escherichia Coli and Enterococci in the collected water samples. This study highlights the importance of evaluating the quality of water in any location before consumption, to determine the necessary measures that should be taken before using it (31). When comparing said study with this research, both texts highlight the importance of evaluating the quality of water before consumption, and of following the standards and regulations established to guarantee safety of water for consumption.

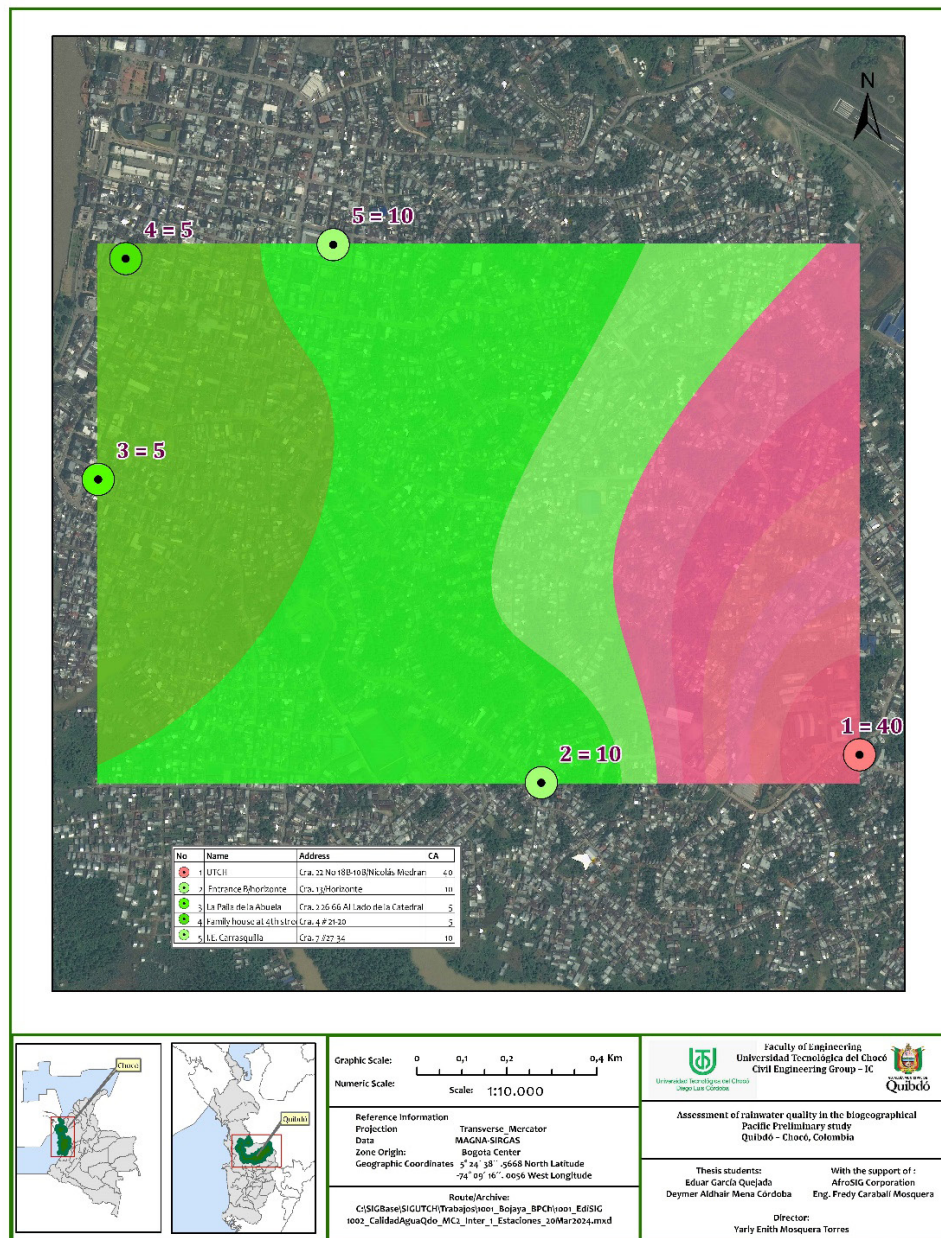
With the values obtained, an extrapolation was made on a map with a physicochemical spectrum, which shows the results of the apparent color (AC) of sampling 1. In this map, it can be seen that points 2, 3, 4, and 5 are shaded with a green color, which means that they comply with the maximum acceptable values whose regulatory range is 15 PCU. However, point 1 of samples 1683WEO1 and 1749WEO1 are above the acceptable value since according to the results they have 40 and 30 PCU respectively, therefore, this parameter in these samples is not admissible. See Figure 14.

Figure 14. Apparent Color (AC) Spatial Distribution Map

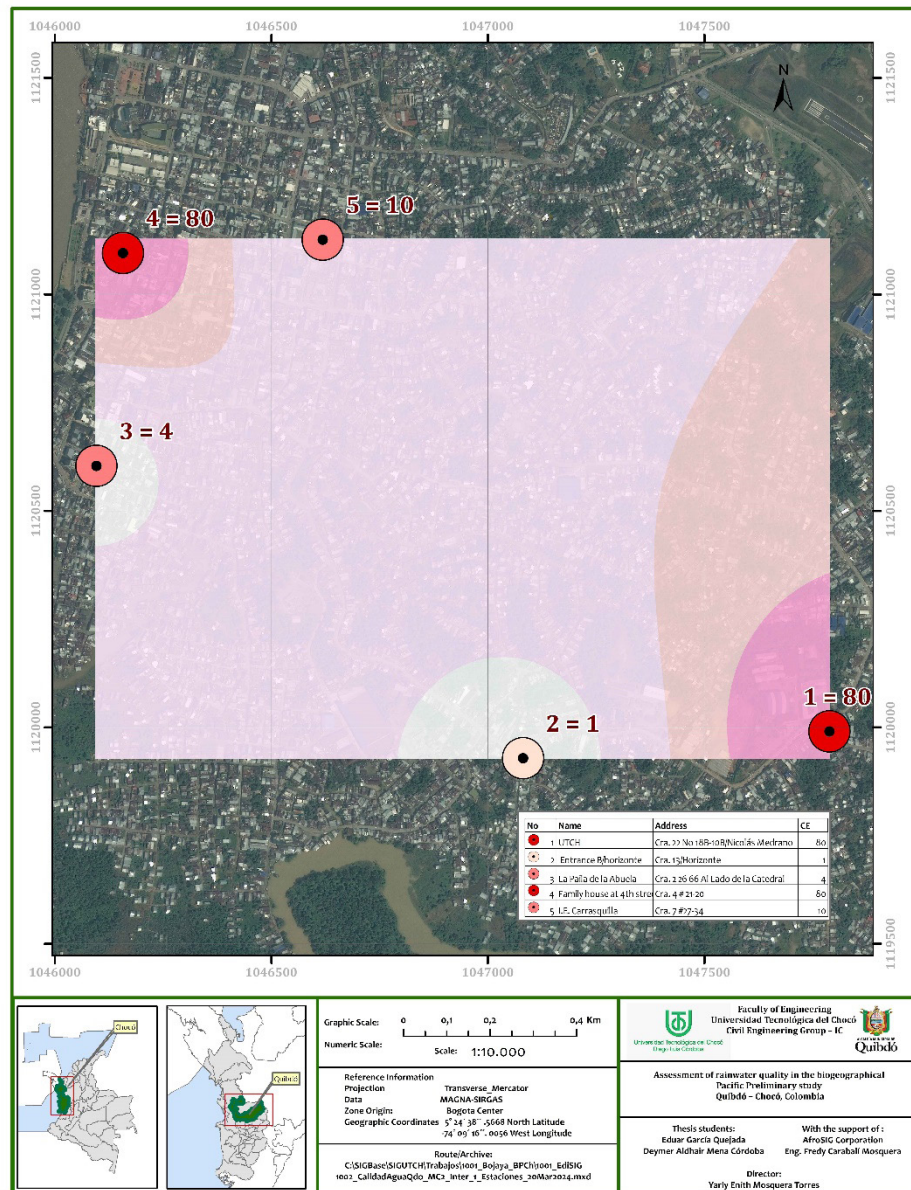
Figure 15. Escherichia Coli (EC) Spatial Distribution Map
