## Assessment of rainwater quality in the biogeographical pacific. Preliminary study Quibdó, Chocó, Colombia

Yarly E. Mosquera-Torres<sup>1</sup>

<sup>1</sup>Grupo de Investigación Ingeniería Civil – IC, Universidad Tecnológica del Chocó, Quibdó, Colombia.

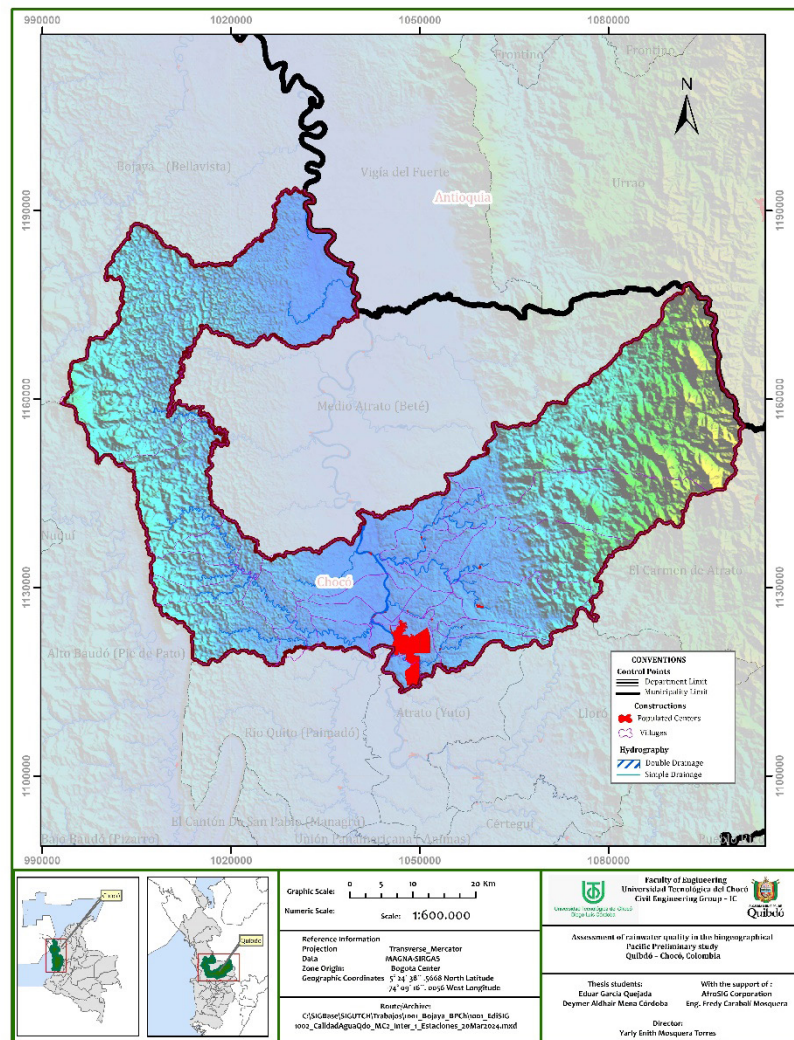
Figure 1. Urban area of the municipality of Quibdó

Quibdó (see figure 1) is the capital of the department of Chocó. Its climate is tropical humid, corresponding to the climate of the Pacific biogeographic region, located on the right bank of the Atrato River at 43 meters above sea level. It has an area of 3,075 Km<sup>2</sup> and a population of 133,906 inhabitants, 84.91% of its population is black and its total income per capita is COP\$ 1,112,119. Allocation of the General Royalties System for the drinking water sector with a cut-off for the year 2020 was 2.73%, despite the fact that the aqueduct coverage is only 25.2% (23).

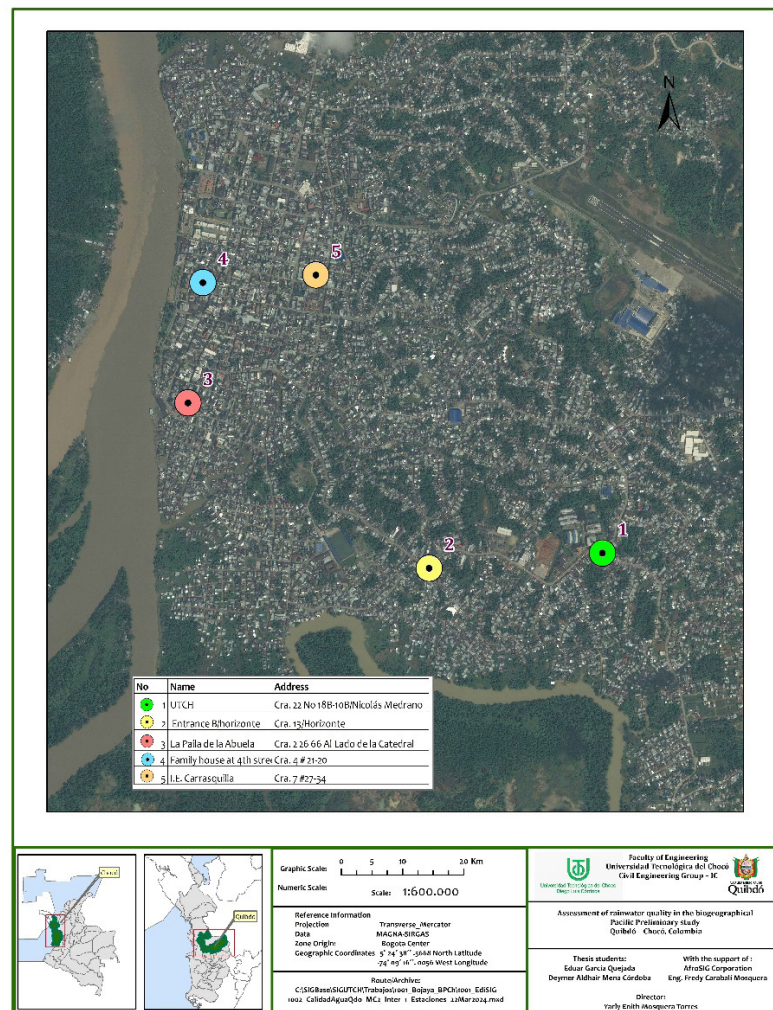
Figure 2. Sampling Points

20 fixed sampling points were established (see Figure 2), using homes that had roofs built of zinc, mantle and asbestos cement, because this type of material is used in the municipality of Quibdó. Additionally, a high vehicular and pedestrian flow was taken into account.

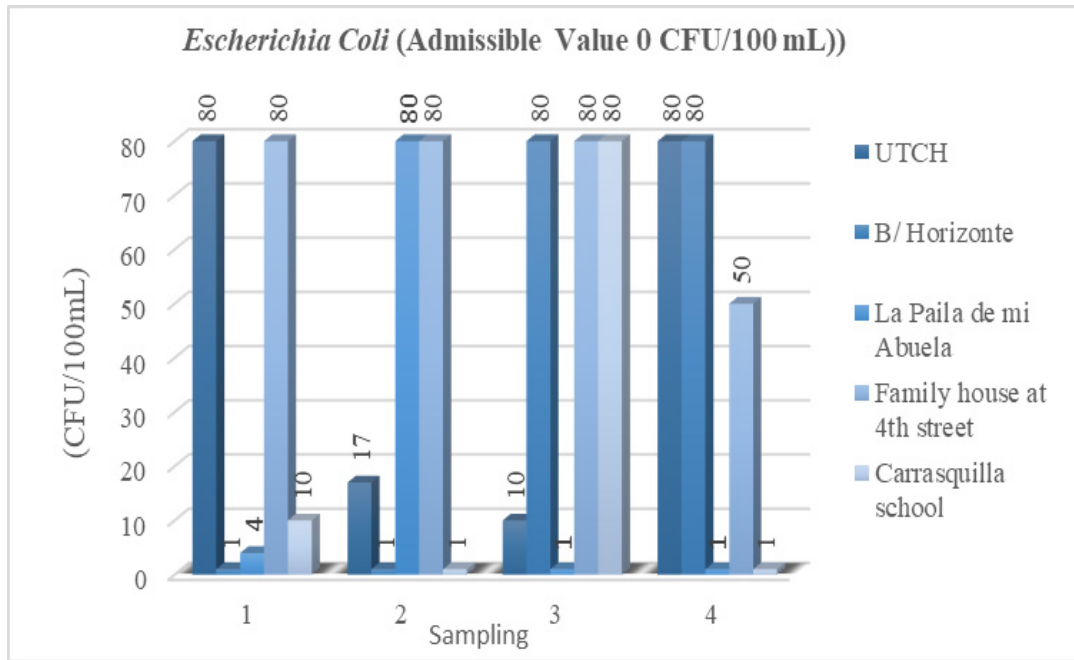
Figure 3. Results of Escherichia Coli

In the microbiological analysis, the presence of colony-forming units of Escherichia Coli and total coliforms was found in 100% of the representative samples, which indicates based on the current standards, that the water is not suitable for human consumption because Resolution 2115 of 2007 establishes that the acceptable admissible value is 0 CFU/100 mL, meaning that no water used for human consumption should contain E. Coli or total Coliforms (22). See Figures 3 and 4.

In addition, Figure 15 (map with a microbiological spectrum) shows the sampling results of the Escherichia Coli (EC) parameter. According to Figures 3 and 4, none of the points meet the values established for this parameter, which must be 0 CFU/100 mL. Points 1 and 4 have a higher intensity, meaning they have higher levels of Escherichia Coli compared to points 2, 3 and 5. This suggests that points 1 and 4 present a greater health risk and require immediate intervention.

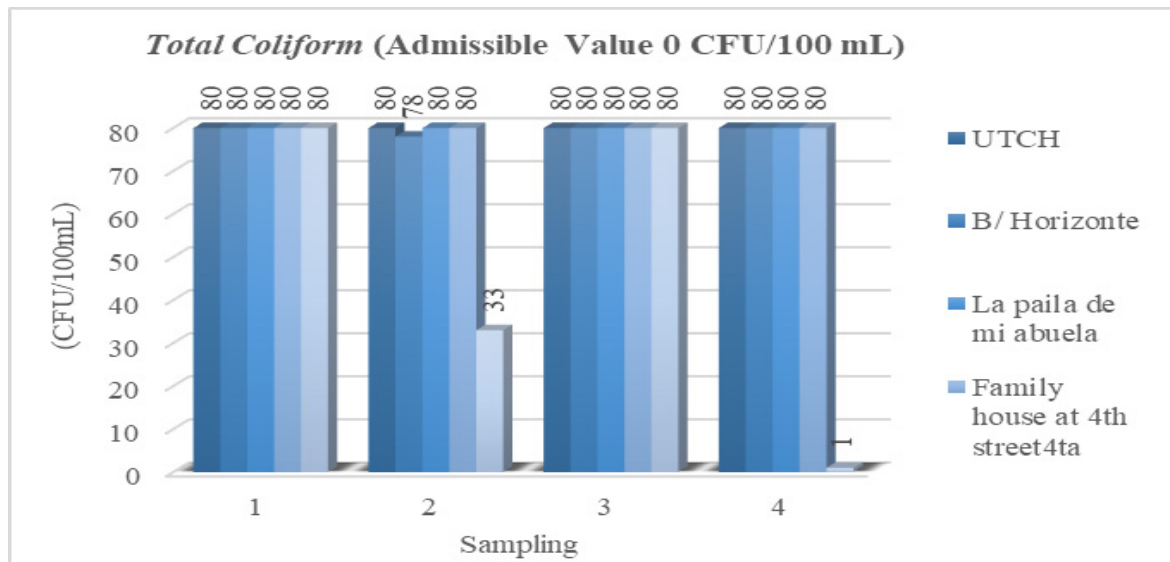
Figure 4. Results of Total Coliform

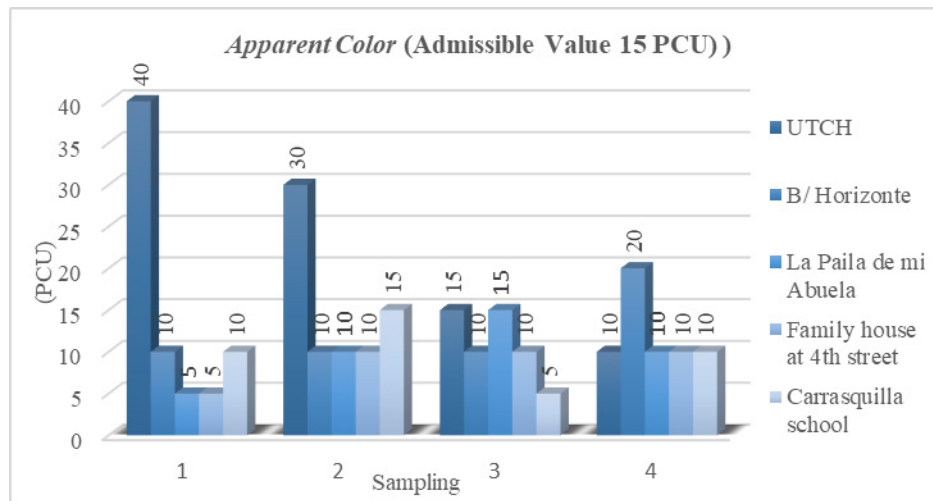
Figure 5. Results of Apparent Color

In the physical analysis, 15% of the samples regarding the apparent color parameter do not meet the admissible value (15 PCU), this could have been caused by slight droughts between the sampling periods. See Figures 5, 6, 7 and 8.

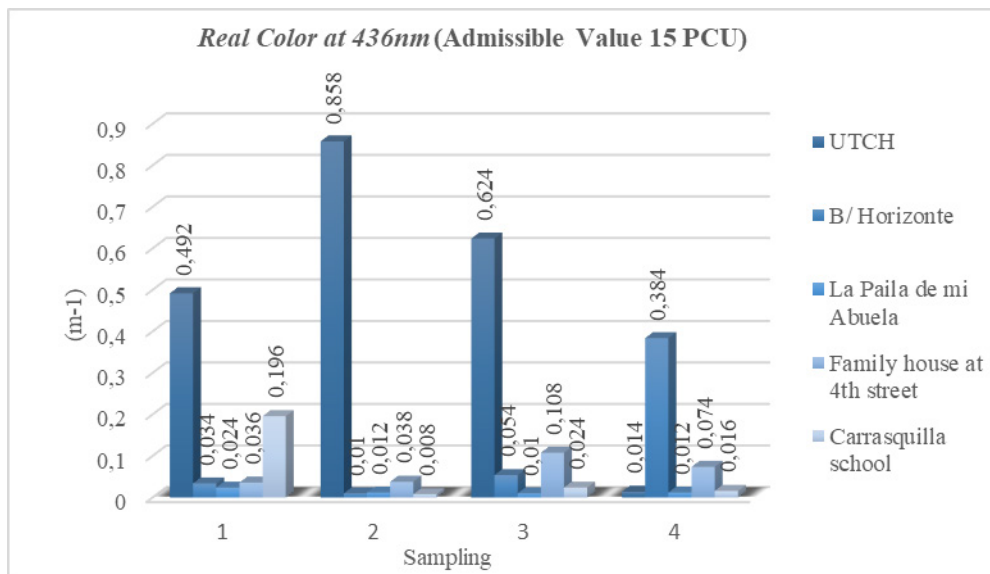
Figure 6. Results of Real Color at 436nm (m-1)

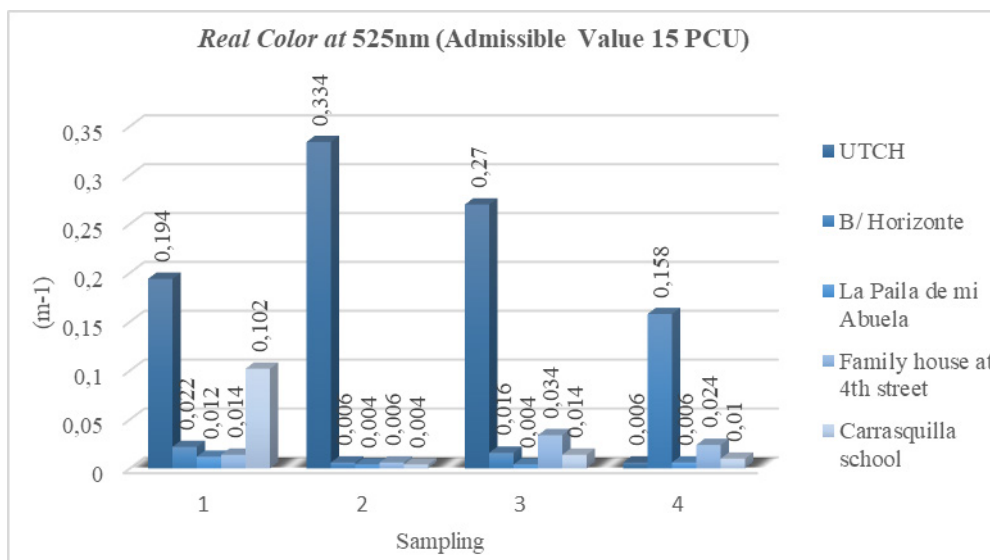
Figure 7. Results of Real Color at 525nm (m-1)

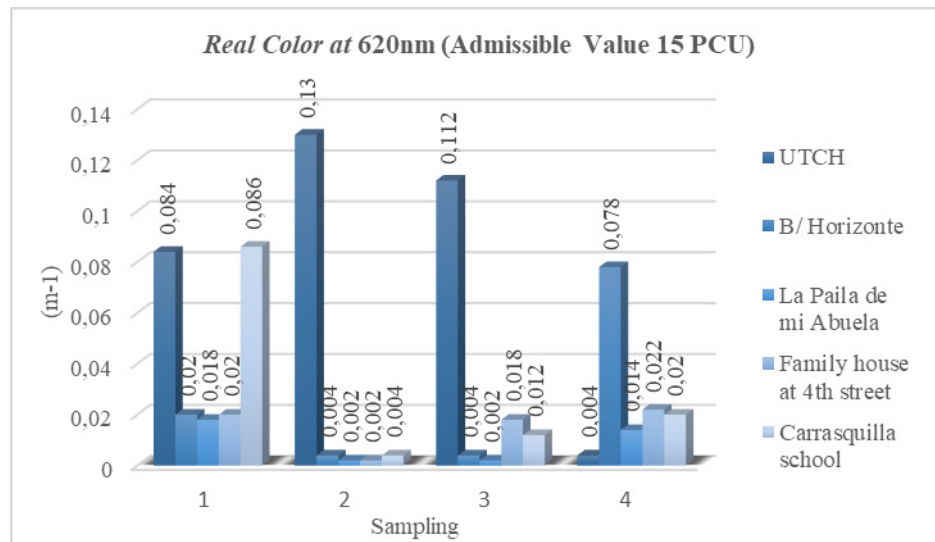
Figure 8. Results of Real Color at 620nm (m-1)

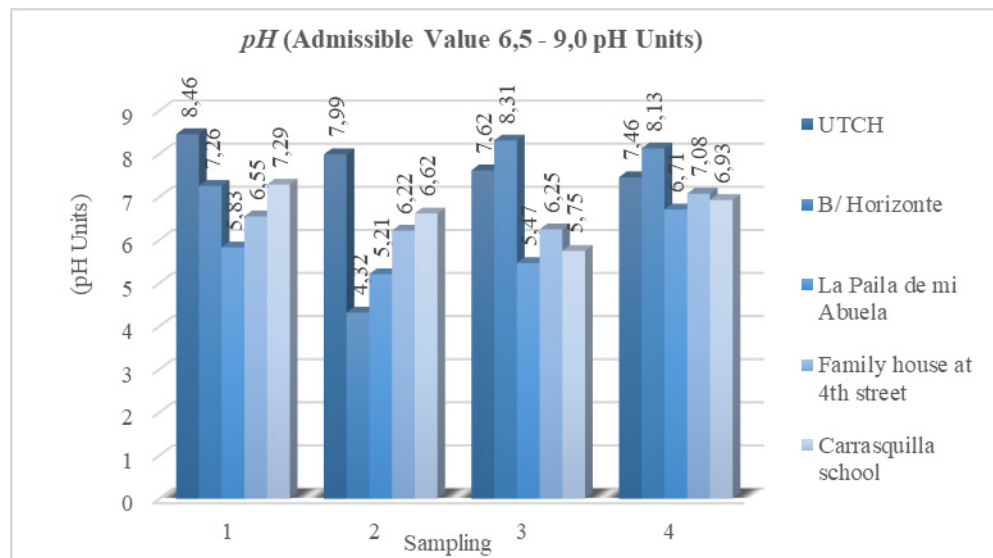
Figure 9. Results of pH

When performing the chemical analysis, 34% of the samples do not comply with the pH parameter since it is below the minimum admissible value, which ranges between 6.5 and 9.0 pH units. The results obtained in the analyzes indicate that the water is acidic, see Figure 9.

The results show that the pH of samples 1683WEO2, 1647WEO3, 1683WEO3, 1749WEO3, 1683WEO4, 1749WEO4 and 1749WEO5 is below the acceptable limit, indicating that the water is acidic. This may have been caused by the weather and atmospheric conditions at the time it was collected. It is observed that the apparent color does not comply with the allowed limits at points 1647WEO1, 1683WEO1 and 1814WEO2, which could be caused by slight droughts during the time of collecting the samples, the time and place in which the collection was carried out. In a study carried out in Guangzhou, South China, the research results showed pH values below the permissible range (29).

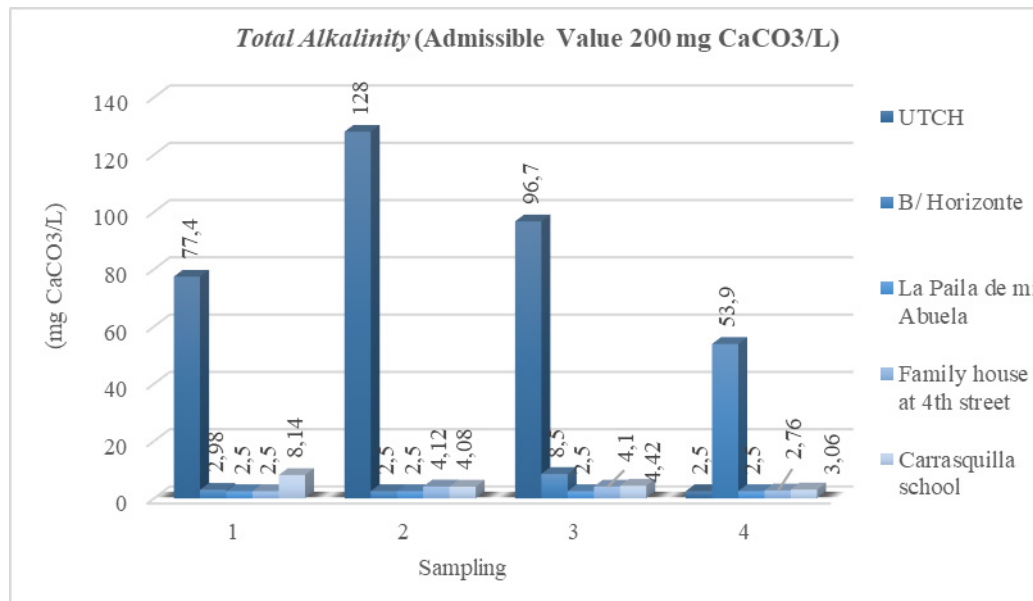
Figure 10. Results of Alkalinity

In relation to the parameters of alkalinity (200 mg CaCO<sub>3</sub>/L), electrical conductivity (1000  $\mu$ s/cm), nitrites (0.1 mg (NO<sub>2</sub>)-/L) and nitrates (10 mg (NO<sub>3</sub>)-/L) it is observed that they are within the admissible values, according to Resolution 2115 of 2007. See Figures 10, 11, 12 y 13.

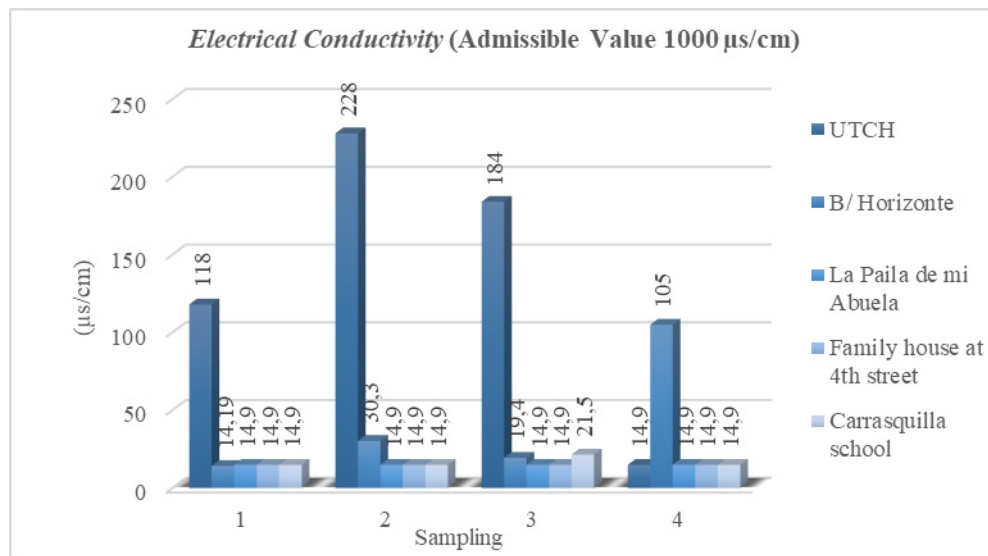
Figure 11. Results of Electrical Conductivity

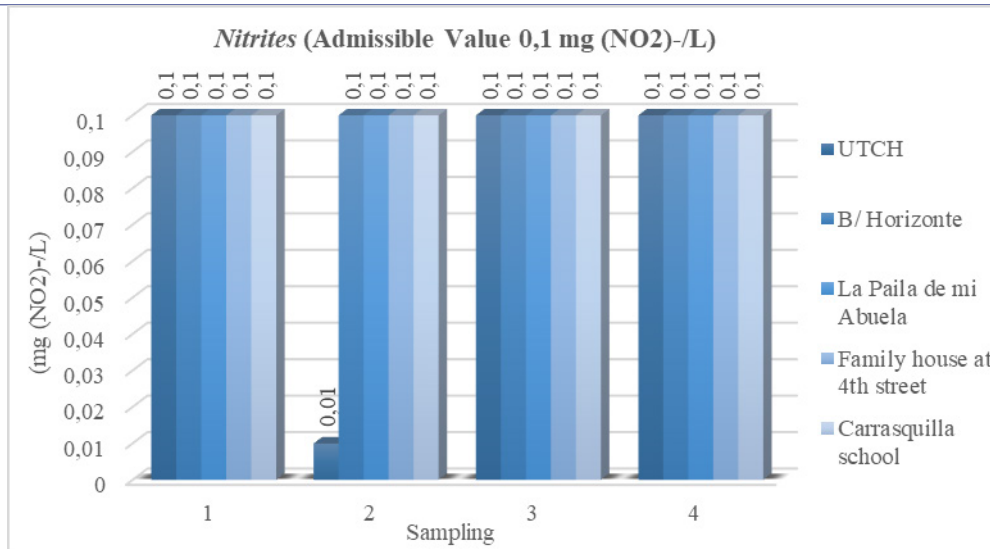
Figure 12. Results of Nitrites

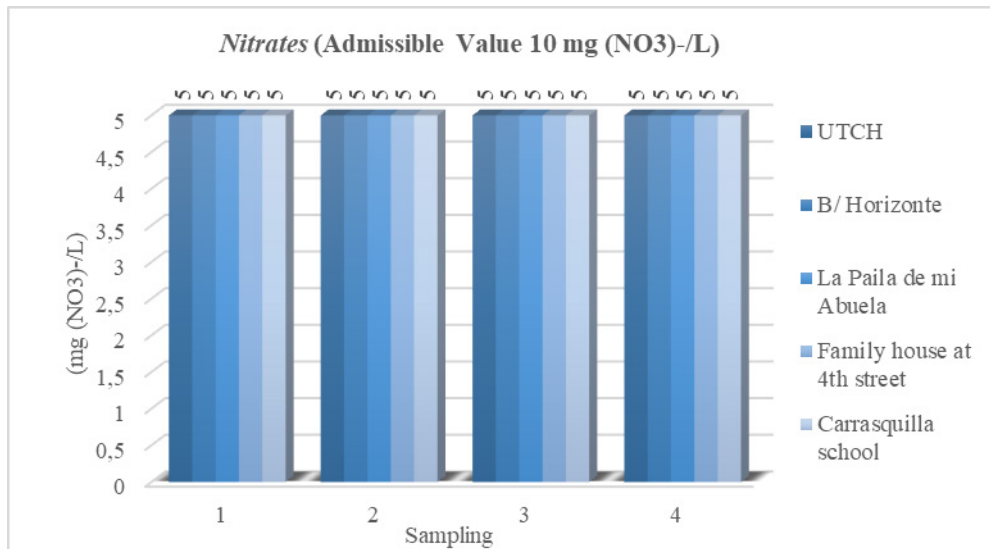
Figure 13. Results of Nitrates

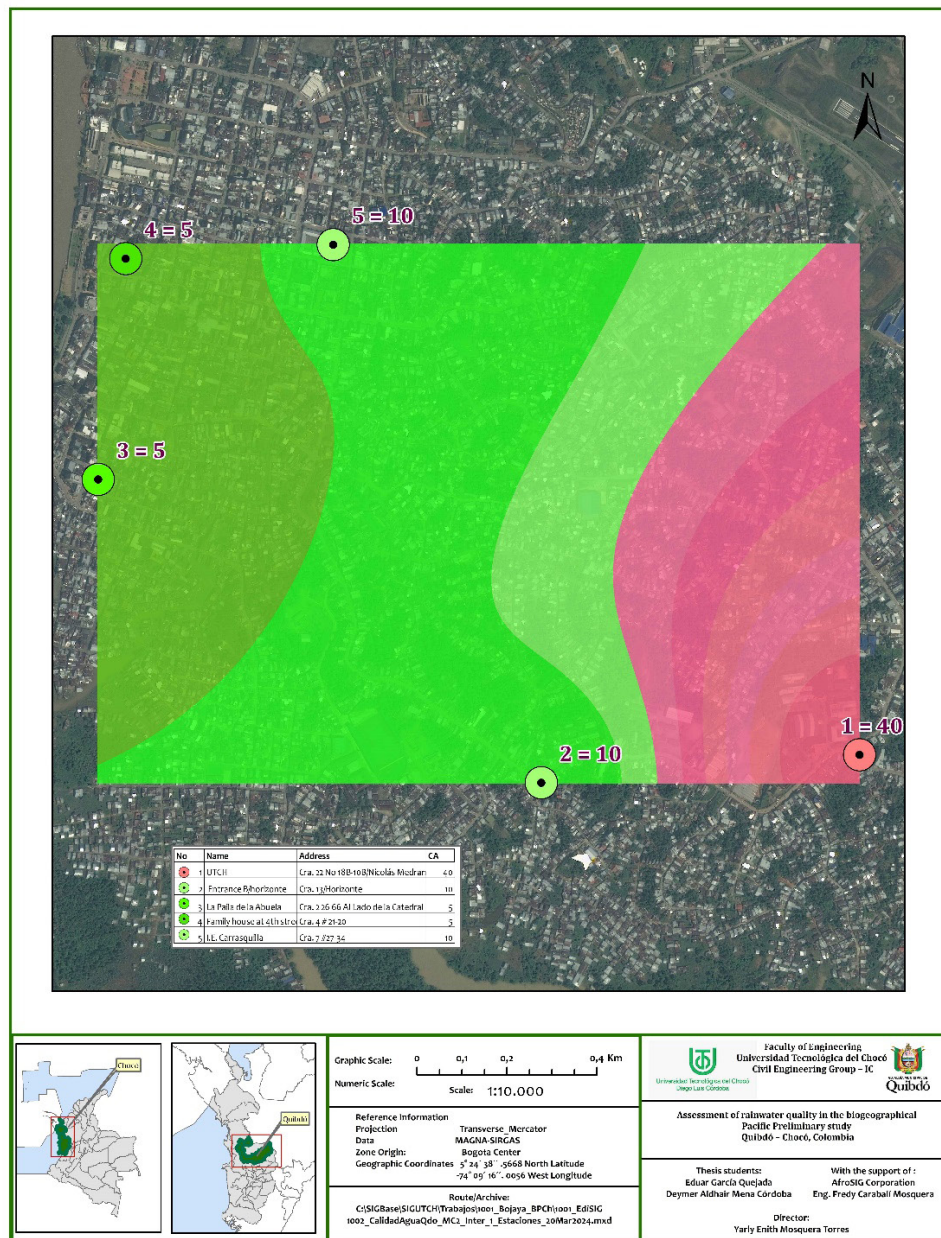
Figure 14. Apparent Color (AC) Spatial Distribution Map

With the values obtained, an extrapolation was made on a map with a physicochemical spectrum, which shows the results of the apparent color (AC) of sampling 1. In this map, it can be seen that points 2, 3, 4, and 5 are shaded with a green color, which means that they comply with the maximum acceptable values whose regulatory range is 15 PCU. However, point 1 of samples 1683WEO1 and 1749WEO1 are above the acceptable value since according to the results they have 40 and 30 PCU respectively, therefore, this parameter in these samples is not admissible. See Figure 14.

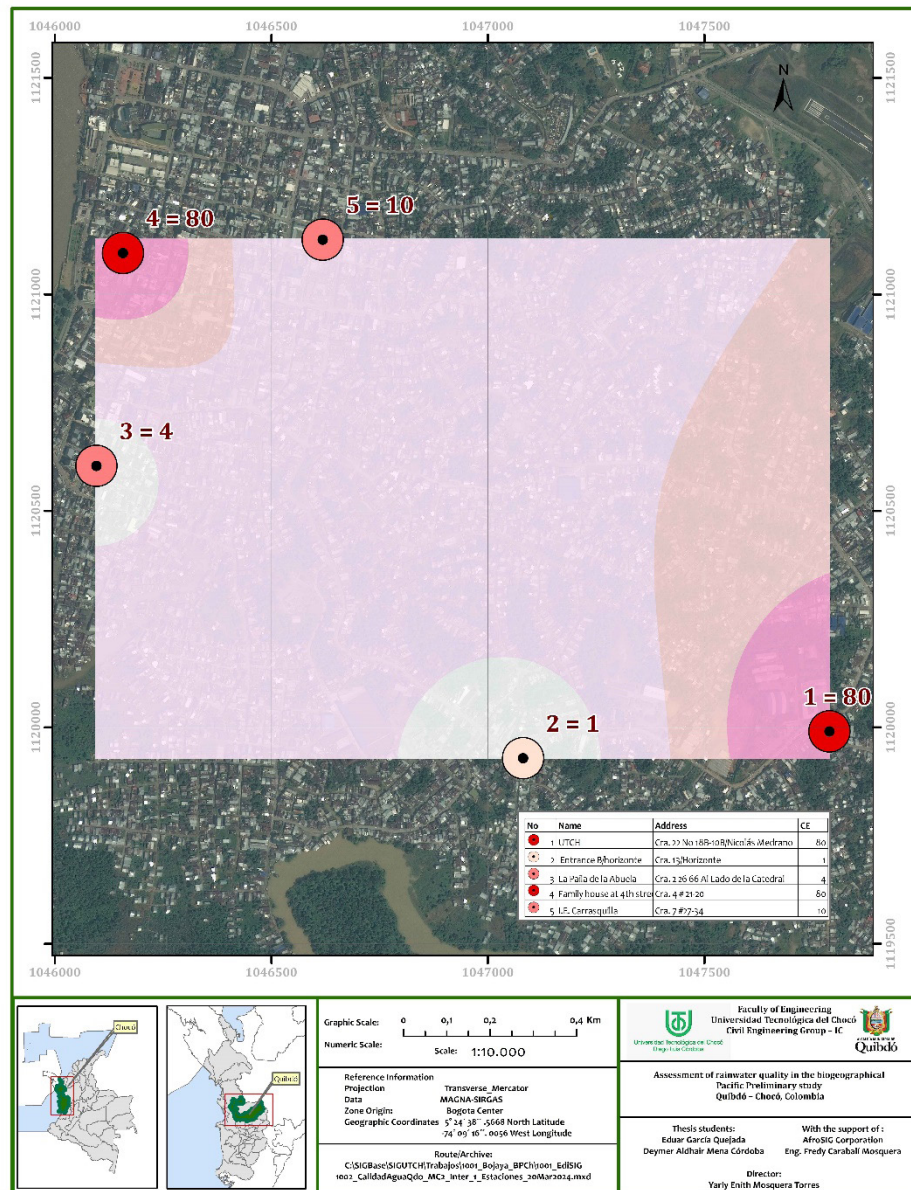
Figure 15. Escherichia Coli (EC) Spatial Distribution Map
